Eliminating Noise during Dual Zone Audio mode with the OS-4.

Pacific Accessory Corporation

This note only pertains to P.A.C. part number OS-4 with a lot number of 002, 003 and 004.

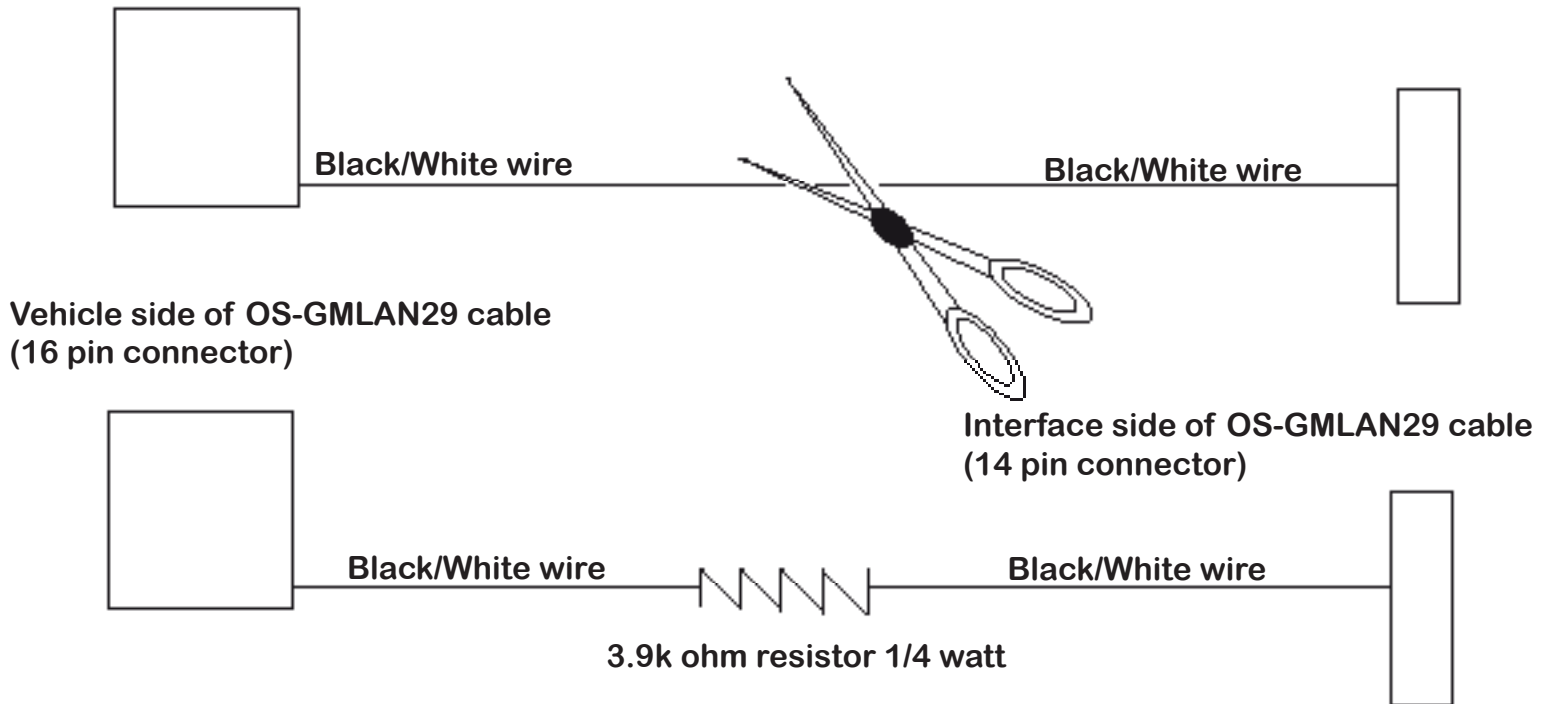
If engine noise is present in the rear speakers when using the dual zone function of the RSE controls or during OnStar:

1. Disconnect the OS-GMLAN29 harness from the vehicle.
2. Locate the Black/White wire terminated at c2 pin 8 (16 pin GM connector)
3. Cut this wire in half.
4. Re-attach this wire by connecting a 3.9k ohm resistor in series (Orange, White, Red, Gold). One side of the resistor to one side of the wire. Other side of the resistor to the other side of the wire.
5. Insulate the new connection and reconnect the OS-GMLAN29 harness to the vehicle and OS-4.
