# Technical Support

## Proper connection of loose wires on PGHGM3 harness

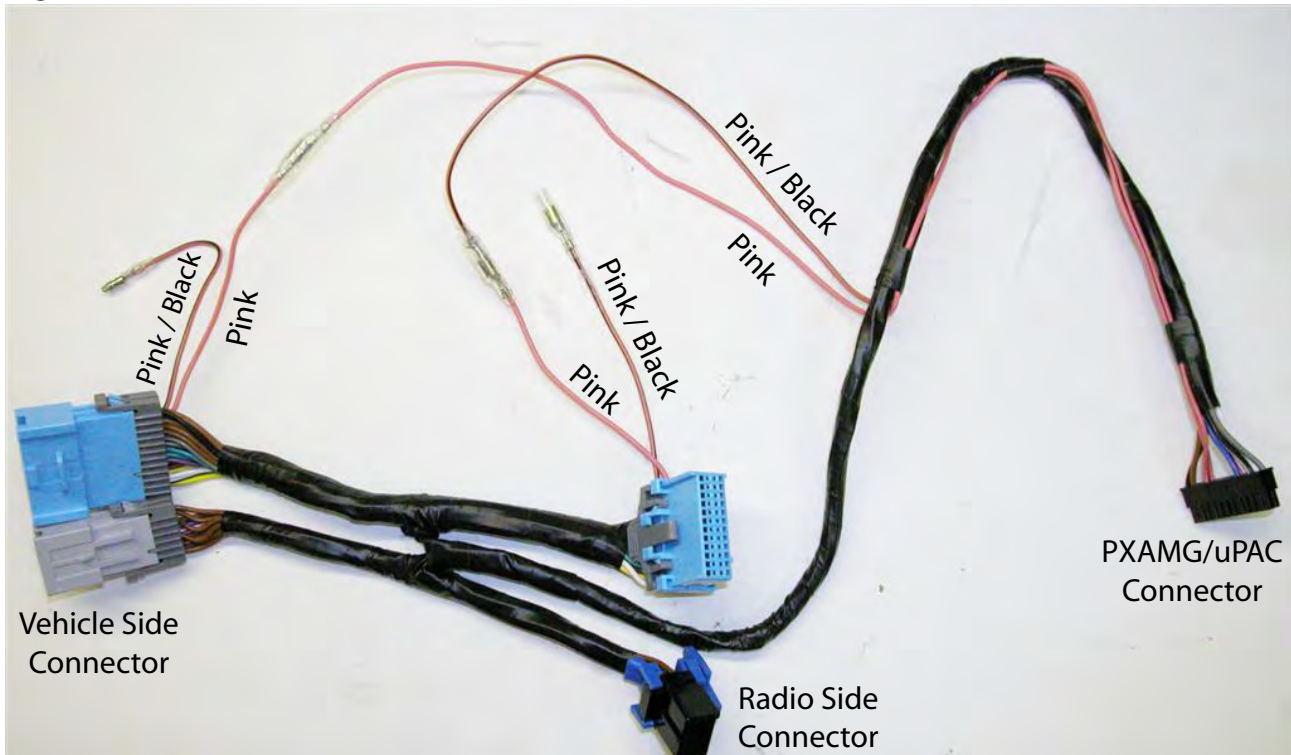
Fig 2.

Configuration 2: Connect the long PINK wire which is coming from the black 24 Pin PXAMG/uPAC module to the shorter PINK wire located on the vehicle side of the harness. Connect the long PINK/BLACK wire which is coming from the black 24 Pin PXAMG/uPAC module to the shorter PINK wire located on the radio side of the harness. Leave the shorter PINK/BLACK wires disconnected and insulate the male connector.

See Fig 2 for illustration

If the first configuration did not work for you, you will need to reset the module and try configuration number 2. For instructions on how to reset the module please visit: <http://www.pac-audio.com/reset>
